EHS ZONE

ENVIRONMENT
HEALTH & SAFETY

EHS資訊板

1) 管理人員工地檢查發現實例

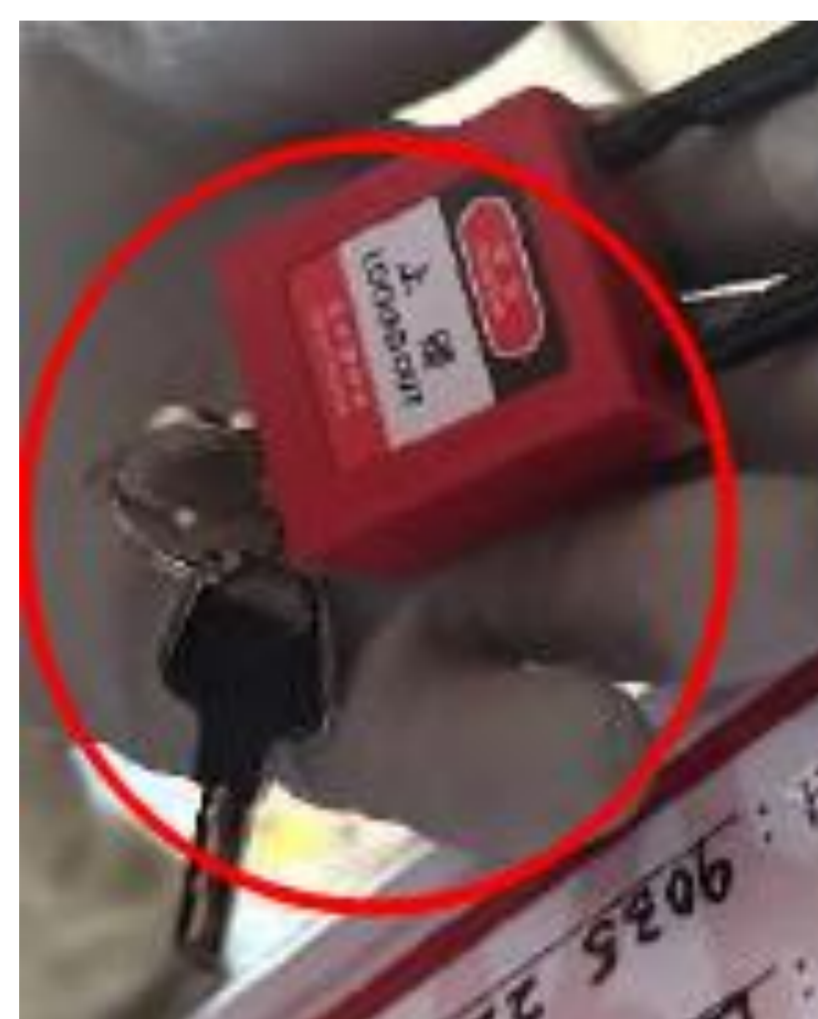
序號	時間	部門	位置	管理人員	工地檢查發現
1	7/5/2026	DFH	Tsuen Wan Centre	Andy Mak, KY Lee	上鎖掛牌的鎖頭及鎖匙沒有標上記號以作識別。
2	28/5/2026	ADV	HKU	Kinnel Lee	電壓測試儀錶未有進行年檢。
3	22/5/2026	DFH	Silvercord	Leung Foon	員工進行處理隔塵網工序時沒有佩戴N95 標準的口罩。

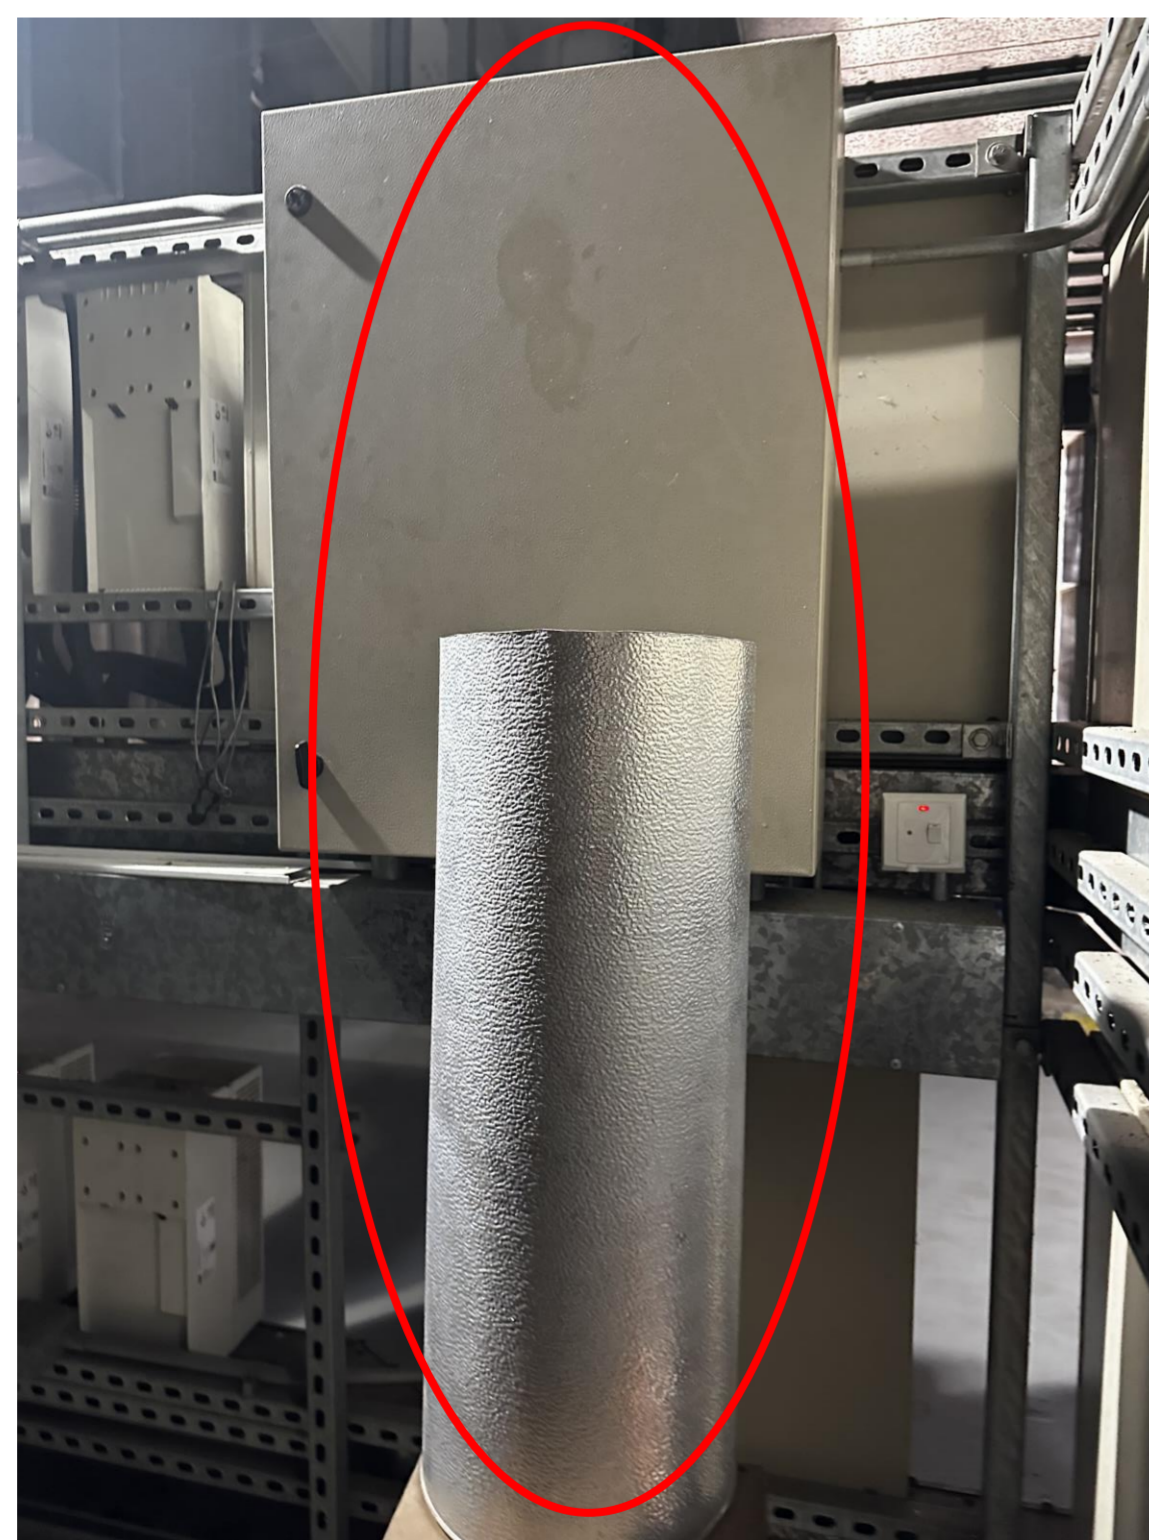
序號	時間	部門	位置	服務技師	工地檢查發現
1	11/5/2026	BMS	MCP Central	Cathy Ho	有些物料被另一分判商堆放, 阻塞了DDC控制面板, 已即時停止相關工作。
2	11/5/2026	MAC	路環監獄	Chan Yat Shing	技術人員發現該入口缺乏適當的圍欄防護措施, 基於安全考慮, 已即時停止相關工作。

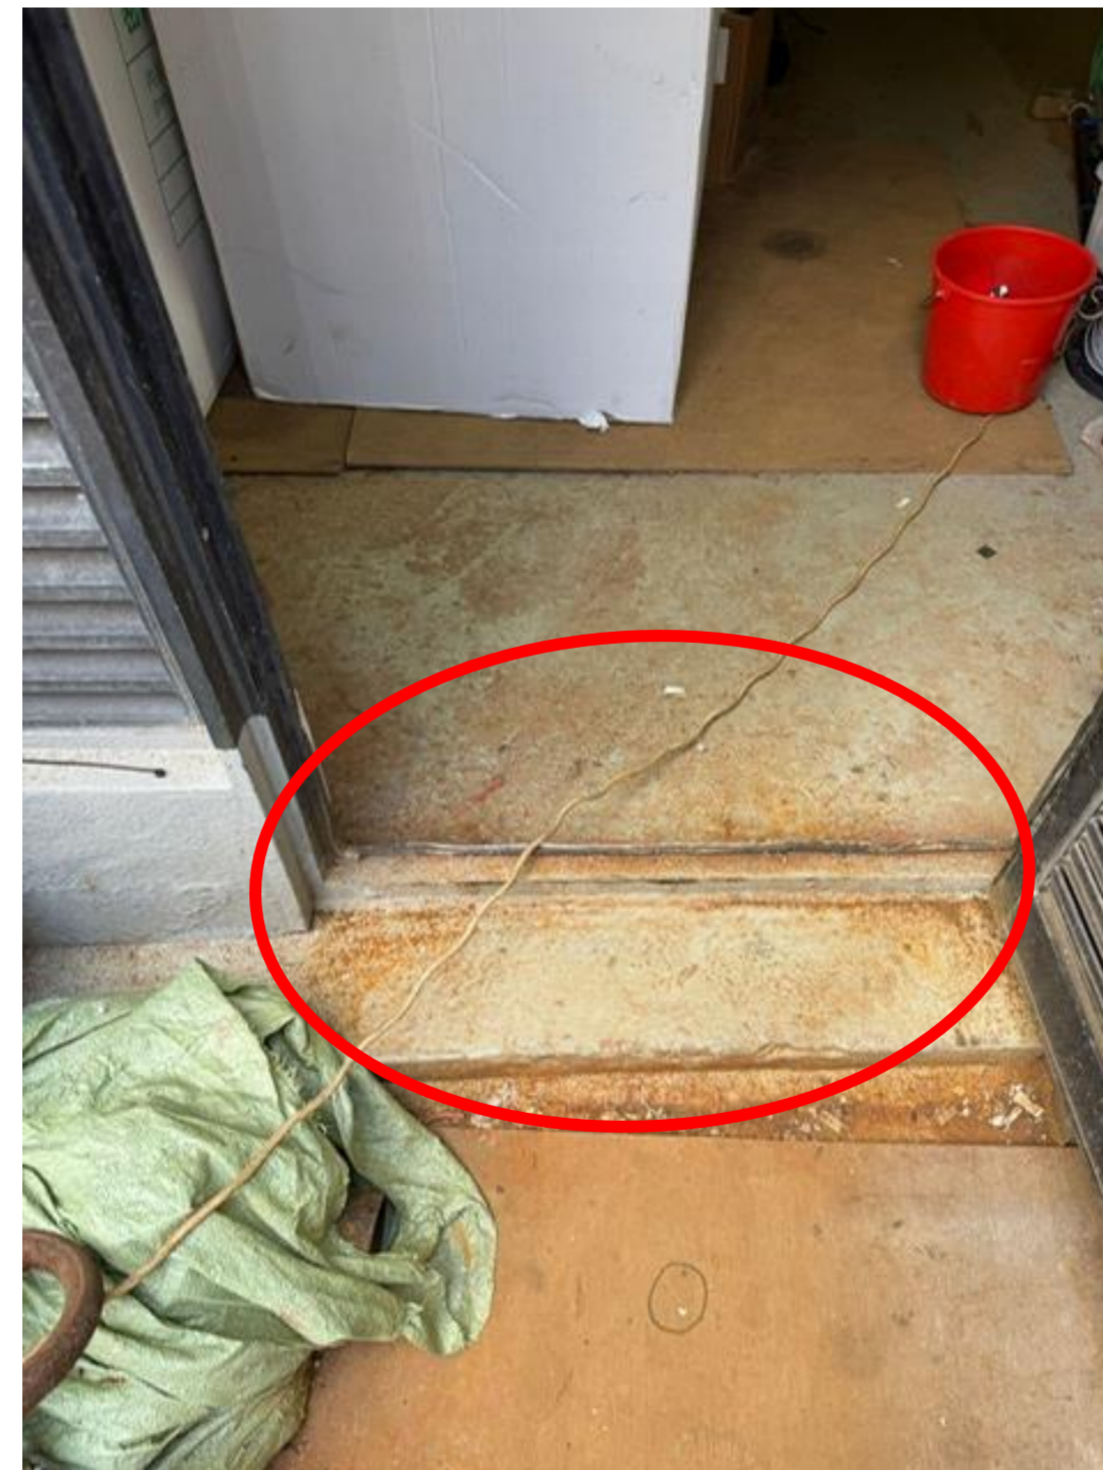
序號真的	時間	部門	位置	服務技師	工地檢查發現
1	19/5/2026	SMD	Rightful Centre	Eric To	工程師經過通道期間, 差點被放在地上的電線絆倒, 未有造成受傷。為避免再次發生同類情況, 已立即將有關電線掛起, 消除有關危險。

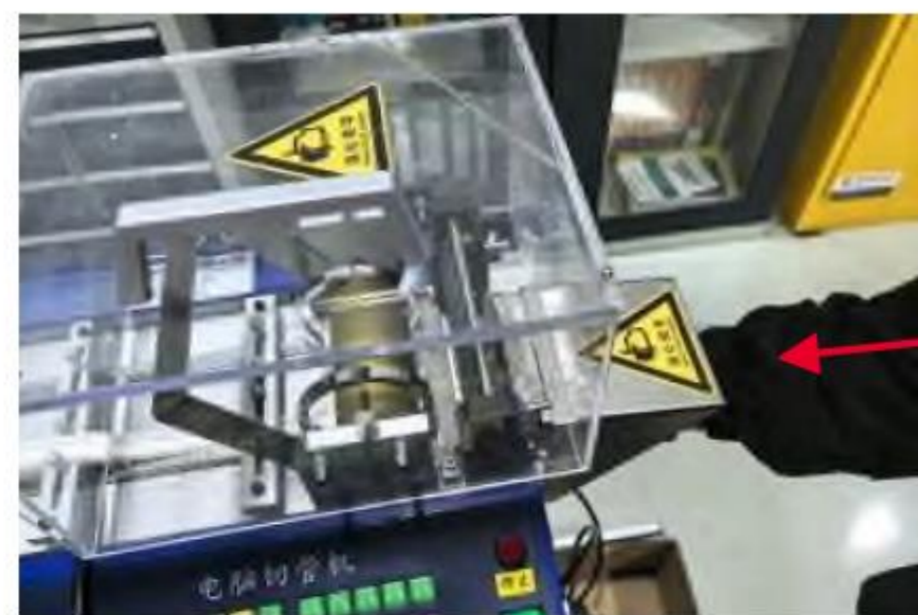
日期	事故等級	地區	事故簡述	調查發現	安全警示
2026年1月6日	二級事故	中國平湖	<p>事故類型：手指被切割機切斷事故</p> <ul style="list-style-type: none"> 一名操作員對橡膠密封切割機（連續切割模式運行的機器）進行開工前準備。發現橡膠密封材料的線圈已經用完，而橡膠卷材的末端留在了機器的出口內。 機器仍在進料和切割，操作員在未停止機器時用右手伸進材料出口處，取下橡膠線圈末端。雖然取下橡膠線圈端，但她兩根指尖手指伸進了仍在運作的機器切割區，導致操作員的右手食指和中指指尖被截斷。 操作員在工廠內立即接受治理，並送往醫院接受進一步治療。 	<p>調查發現：</p> <ul style="list-style-type: none"> 操作員在機器仍在運轉時伸手進入切割機的出口取出橡膠線圈末端。 已安裝的機器防護設備未能有效阻止手進入機器。 操作員違反了機器安全程序和標準作業指示 (SWI)，在機器仍在運行時不應移除橡膠卷端。 標準作業指示 (SWI) 沒有足夠的詳細說明，無法充分說明如何拆除橡膠卷端、操作模式差異以及一般機器安全。 工作危害分析 (JHA) 未能識別所有機器危害及控制措施。 有關操作此機器的培訓和認識不夠全面。 機器防護檢查計劃未能識別此機器的危險情況。 	<ol style="list-style-type: none"> 已立即停工，並將 BBS 計劃擴展至所有機器。 對此機器及類似機器立即進行機器安全防護檢討。 更新標準作業指示 (SWI)，包括拆除橡膠線圈末端、切割模式及其他安全控制措施。 制定改進的機器安全防護檢查計劃，明確檢查的頻率、範圍及責任。 更新該機器的工作危害分析 (JHA)，以識別並記錄所有危害及控制措施。 針對更新 JHA 的意外檢討會議，提高操作員對工作特定危害的認識。 安裝兩個手控裝置以及安全互鎖重置，以便此機器在停機後重新啟動。 改進此機器的安全防護，全面保護轉動部件和操作點。 對所有設備實施“意外後檢討”檢查，並根據需要改進機器安全防護。 跨部門員工每週進行現場巡查 (Gemba Walk)，以確保更精準識別到不安全狀況。 審查全面生產保養 (TPM) 計劃，確保機器維護按原始設備製造商 (OEM) 要求執行。 進行全廠風險評估審查，以系統性識別未被認識的危害。

受傷時的手部活動情況

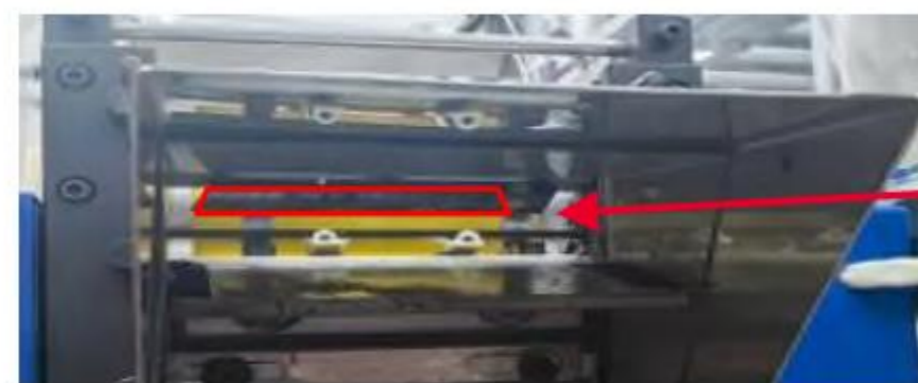
截斷手指的刀片

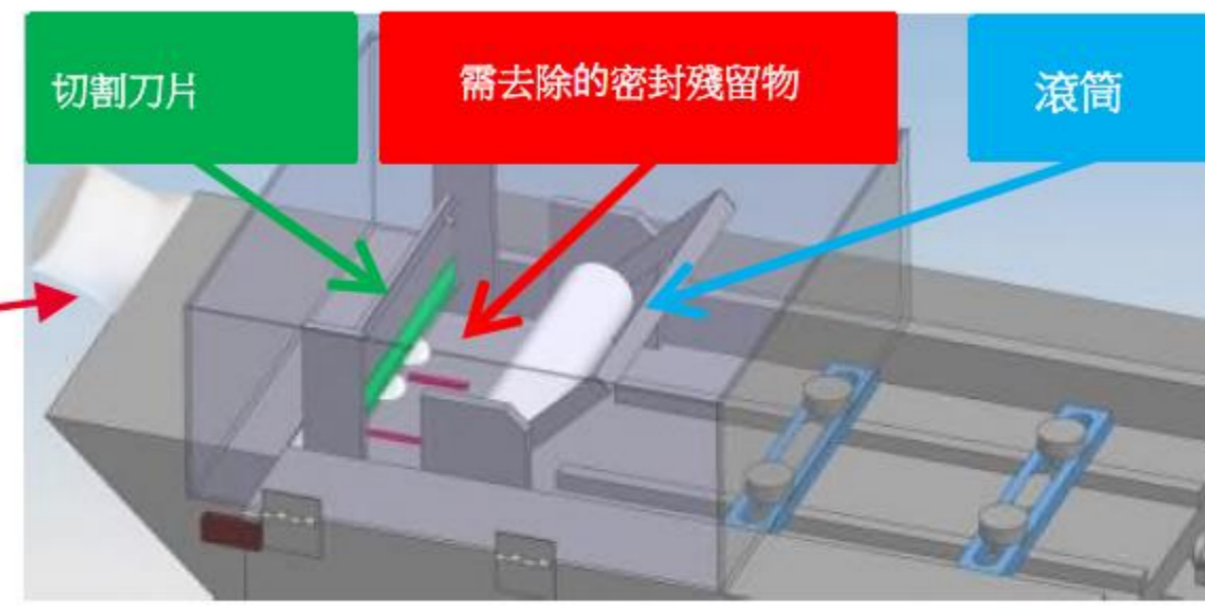
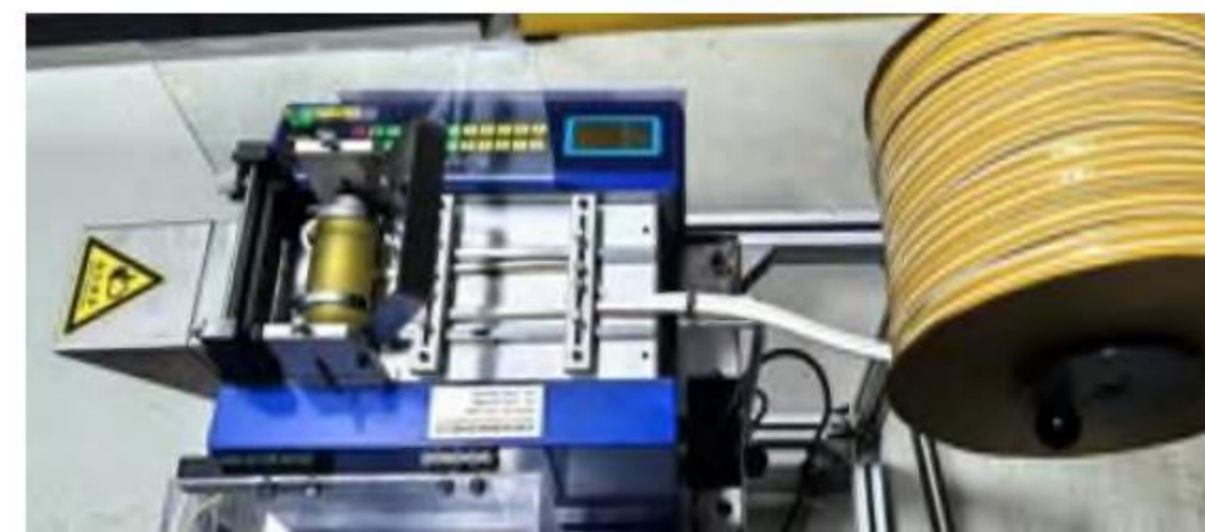
手部伸進機器出口的正面圖
